# Camera Health Report

## Dowanhill Medical Center

Report Generated: August 26, 2026

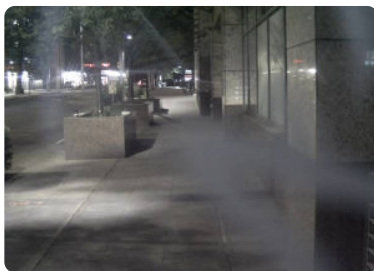
#### Byres Road Clinic - GD NJB Sign SE (W) 733

Dome Haze Outdoor Low Light Landscape

The image shows an outdoor sidewalk scene under low light conditions, with a building on the right and streetlights illuminating the area. There is noticeable dome haze affecting the entire frame, with a smooth gradient cloudiness spreading inward from the edges and significantly obscuring the action zone in the bottom two-thirds of the image. This degradation requires a dome replacement to restore clear visibility.

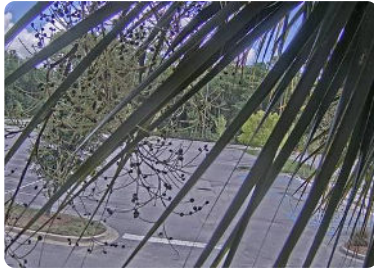
### Byres Road Clinic - MOB Employee Parking (10\_24\_5\_)

Recently Degraded

Occlusion Vegetation

The image shows an outdoor scene of a parking lot and surrounding greenery under uniform lighting in landscape orientation. Large palm fronds and branches extend into the bottom two-thirds of the frame, partially obscuring the view and reducing visibility in the action zone. This occlusion by vegetation requires on-site clearance to restore full camera coverage, resulting in a total quality score of 2.82/5.0.

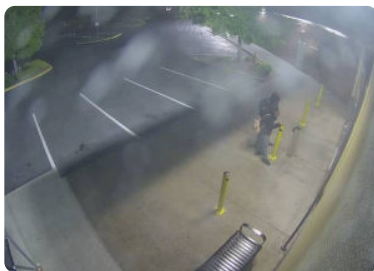
### MLT 004(3)

Dome Dust

The image shows an outdoor scene at night under IR illumination, capturing a sidewalk area with bollards and a parking lot. The image quality is degraded by dome dust, visible as numerous bright circular spots scattered across the frame, which significantly reduces clarity in the action zone (bottom two-thirds). This defect results in a total score of 2.86/5.0 and requires technician intervention to clean or replace the dome.

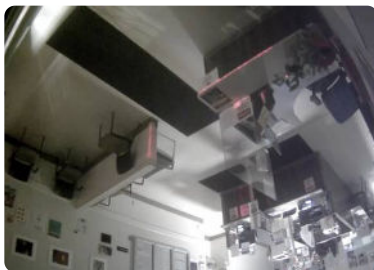
### PSQ-GD Main Lobby - 802

Image Rotation

The image shows an indoor scene with mixed lighting, captured in portrait orientation but displayed upside-down, resulting in the ceiling and upper walls appearing at the bottom of the frame. This incorrect image rotation significantly impacts the usability of the action zone in the bottom two-thirds of the frame, scoring 2.90/5.0. The issue is settings-addressable and can be corrected remotely by adjusting the camera's image rotation settings.

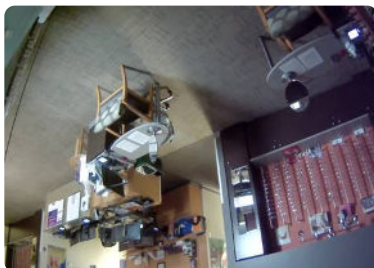
### NJB Eyes on James Lobby 730

Image Rotation

The image shows an indoor retail environment with mixed lighting, capturing a display area and seating arrangement in landscape orientation. The frame is incorrectly rotated, causing the scene to appear upside-down, which affects the usability of the action zone in the bottom two-thirds of the frame. This issue is settings-addressable and can be corrected remotely to restore proper image orientation.

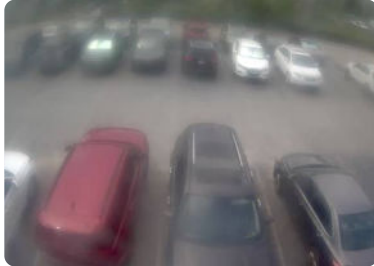
### SFX MRI Outside (10\_16\_28\_46)

Dome Haze

The image shows an outdoor parking lot with multiple vehicles parked in rows under uniform lighting in a landscape orientation. The image quality is significantly degraded by dome haze, which causes a smooth gradient cloudiness spreading inward from the edges and obscures details in the action zone (bottom two-thirds of the frame). This defect results in a low total score of 2.82/5.0 and indicates that the dome cover should be replaced to restore clear visibility.
